Manhole Inspection Summary

Manhole # S31E__042MH

Location Address: **side of 112 n eutaw st**

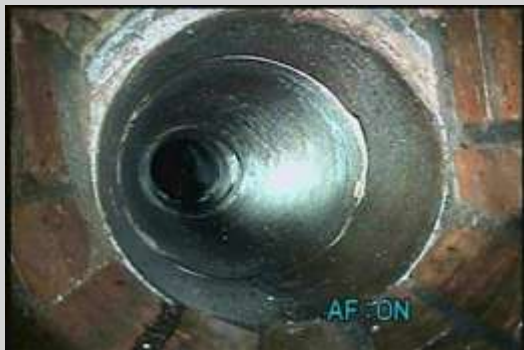
12 O'Clock Outflow

10 in. Circular Gravity Sewer
Pipe Out @ 12 O'Clock

Pipe Material: **Clay** ☐ Pipe Lined

Invert Depth: 11.41 (ft.) Flow Characteristics: **None**

Infiltration: **None** Pipe Seal Cond: **Unknown**

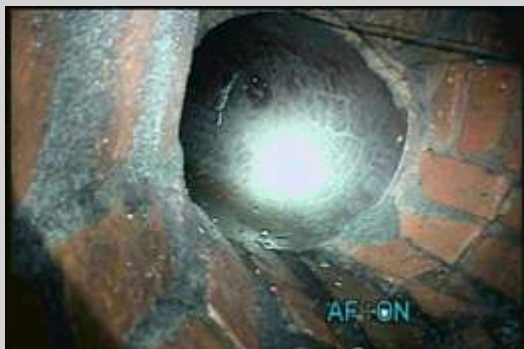
7 O'Clock Inflow

10 in. Circular Gravity Sewer
Pipe In @ 7 O'Clock

Pipe Material: **Clay** ☐ Pipe Lined

Infiltration: **None** Pipe Seal Cond: **Unknown**
